Benthic Survey Report for The Bay Park

Phase 1 Site Development

Sarasota, Florida

September 2020

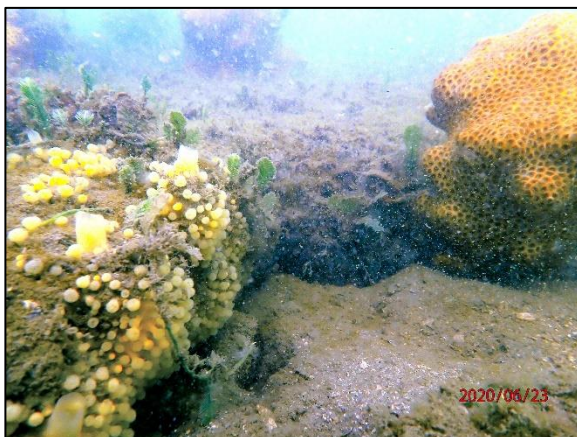
Photo 6. Hardbottom habitat with hard coral and emergent rock

Habitats observed and mapped are shown in **Figure 4**; hardbottom habitat (**Photo 6**) was the most abundant covering 3.49 acres [14,124 m²] (field verified and interpolated) in the western portion of the survey area and SAV habitat (**Photo 7**) in varying abundances covering 1.58 acres (6,394 m²). Along the eastern shoreline, artificial hardbottom/riprap (**Photo 8**) comprised of small boulders and rocks are lined along the banks, having been placed there to minimize erosion and scouring of the shoreline. Parts of the shoreline, along the southern bank of the Project area, were rehabilitated into a resilient ecological shoreline, replacing an old crumbling seawall with a sloping shoreline comprised of four small, emergent groins that dissipate wave energy. Submerged aquatic vegetation (**Section 3.2.1**) was observed just west of the riprap either as scattered seagrass with mixed macroalgae or as continuous beds of seagrass in varying abundances. Separating seagrass and hardbottom areas, in slightly deeper waters, was unvegetated softbottom habitat (**Photo 9**) with minimal to no flora or fauna present. Hardbottom habitat (**Section 3.2.2**), as either continual hardbottom or interspersed with sediment layers, was found in the central and western most survey areas.

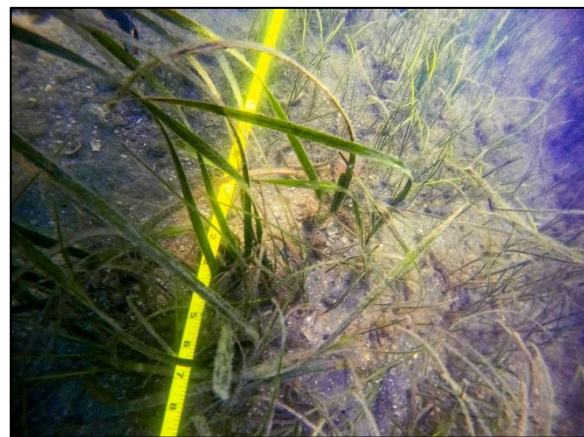
Photo 7. SAV habitat with mixed seagrass and macroalgae

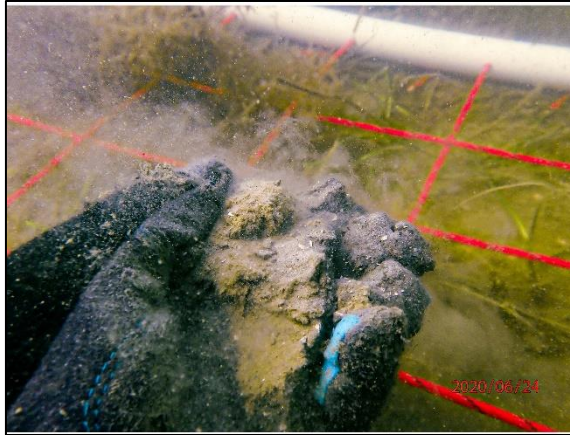
Photo 10. Silty sand substrate in the southern portion of the survey area.

Sediment types within the SAV habitat were primarily silty sand and fine sands (**Photo 10**) in the southern and central portions of the survey area, transitioning more to medium sands and shell hash (**Photo 11**) progressing to the north. Epiphytic coverage was observed in lower to moderate levels when shoal grass was the predominant species and in higher coverages where manatee and turtle grasses were documented (**Photo 12**). Similarly, drift algae were more common and in higher coverages where the taller (e.g., manatee grass) and wider bladed (e.g., turtle grass) seagrasses were located (**Photo 13**). Mean emergent short shoot counts and blade (canopy) height for all species is provide in **Table 6**. Not unexpectedly, due to their growth form and narrower shoot and blade configurations, *H. wrightii* (shoal grass) and *S. filiforme* (manatee grass) had higher mean shoot count densities at 365 ± 218 and 345 ± 188 shoots/m², respectively, than *T. testudinum* (turtle grass) with 49 ± 27 shoots/m². Mean Blade (canopy) height was greatest for *T. testudinum* (turtle grass) at 45 ± 9 cm and *S. filiforme* (manatee grass) at 41 ± 10 cm (**Photo 14**), with *H. wrightii*'s (shoal grass) mean blade length much lower at 23 ± 5 cm.

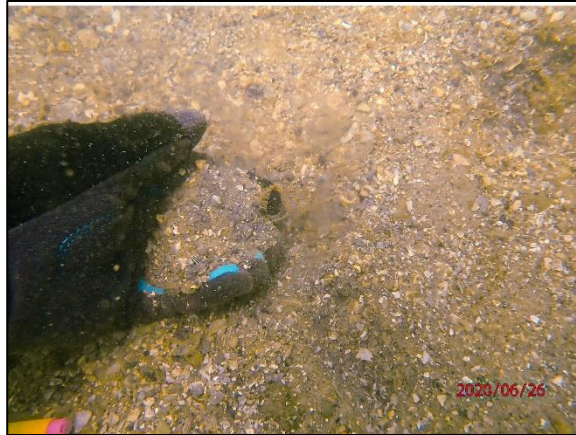
Photo 11. Medium sands with shell hash in the northern portion of the survey area.

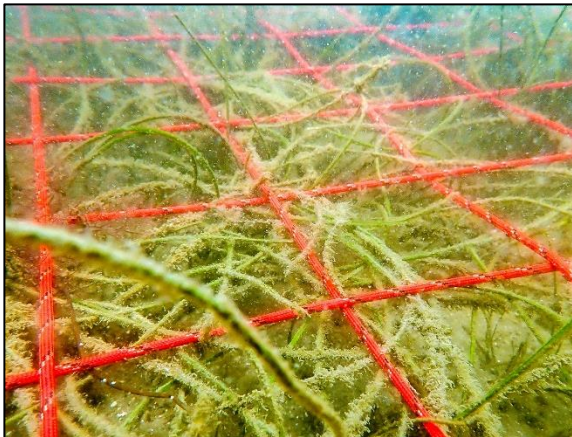
Photo 12. Heavy epiphytic coverage on manatee grass (*Syringodium filiforme*).

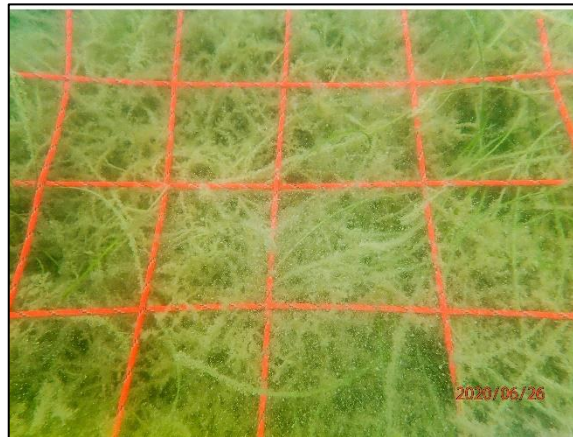
Photo 13. High percentage of drift algae in SAV habitat

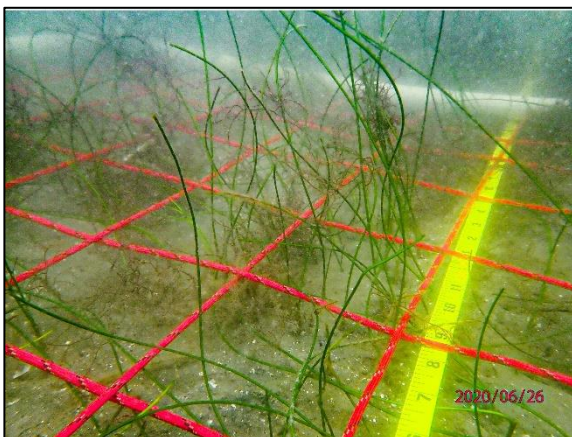
Photo 14. Manatee grass (*Syringodium filiforme*) displaying taller blade canopy

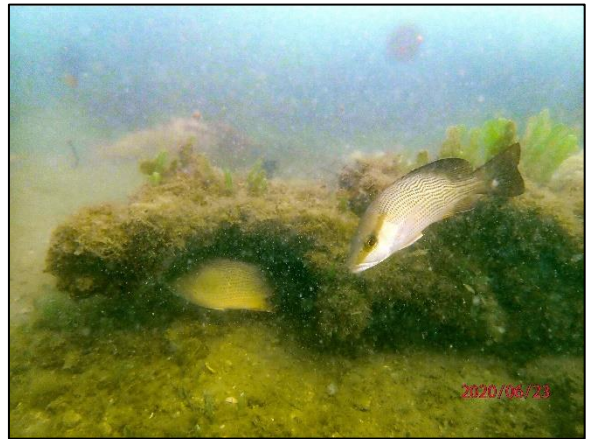
Photo 20. Hardbottom ledge with gray snapper (*Lutjanus griseus*)

As described in **Table 1**, hardbottom habitat in the survey area varied from exposed limestone bedrock, small ledges, and rocky outcroppings (**Photo 20**) to open areas of sand overlying bedrock with emergent hardbottom fauna, at times resembling softbottom habitat with the exception of the presence of “reef” epifaunal organisms. By nature, hard corals and octocorals are sessile and require solid, stable substrate to attach to and grow. Within the survey area, the presence of these Gulf coast “reef” fauna extending upward from what appears to be softbottom habitat (e.g, sand) indicates submerged bedrock is present beneath the overlying sediments and is defined as hardbottom habitat.

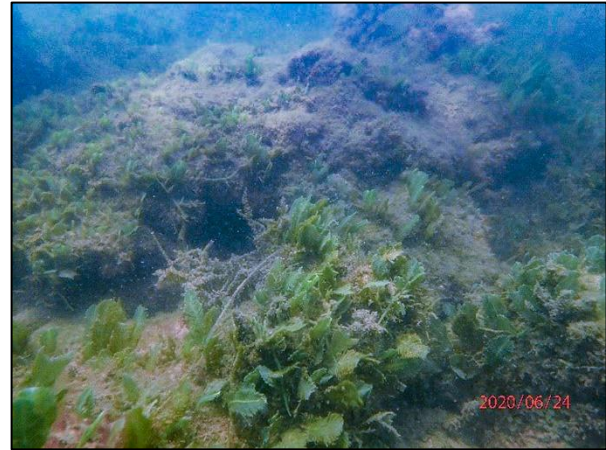
Photo 27. Riprap colonized with macroalgae along the shoreline

The eastern shoreline consists of bulkhead and/or riprap colonized with turf algae and macroalgae (**Photo 27**) and a few sparse colonies of the lesser starlet coral *Siderastrea radians*, a small shallow-water coral commonly found on artificial habitats such as boulders and seawalls. Numerous crabs, small fish, mollusks, and small shrimp were observed taking refuge within the crevices and amongst the macroalgae. A West Indian Manatee aggregation was also seen swimming within close proximity to the shoreline.
