2019 Sarasota Bay Phase I – Marine Resource Survey Report

Report Date: September 26, 2019

Issued To: Sarasota Bayfront Planning Organization

Survey Date: August 27, 2019

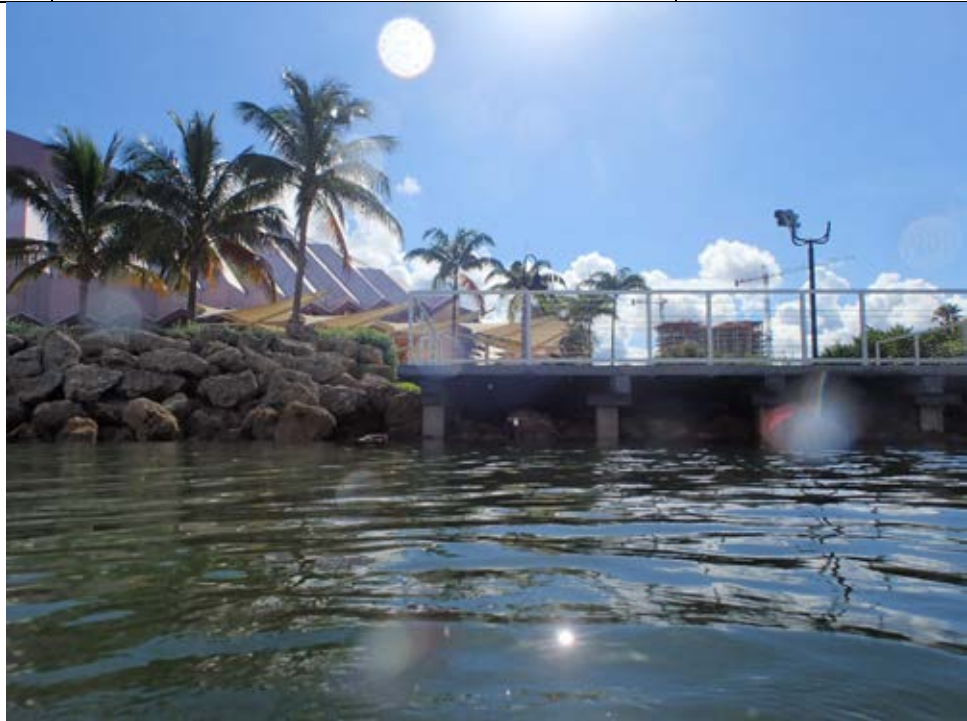
1

Transect A extended
330 feet west of the
northern edge of
the existing sun deck.

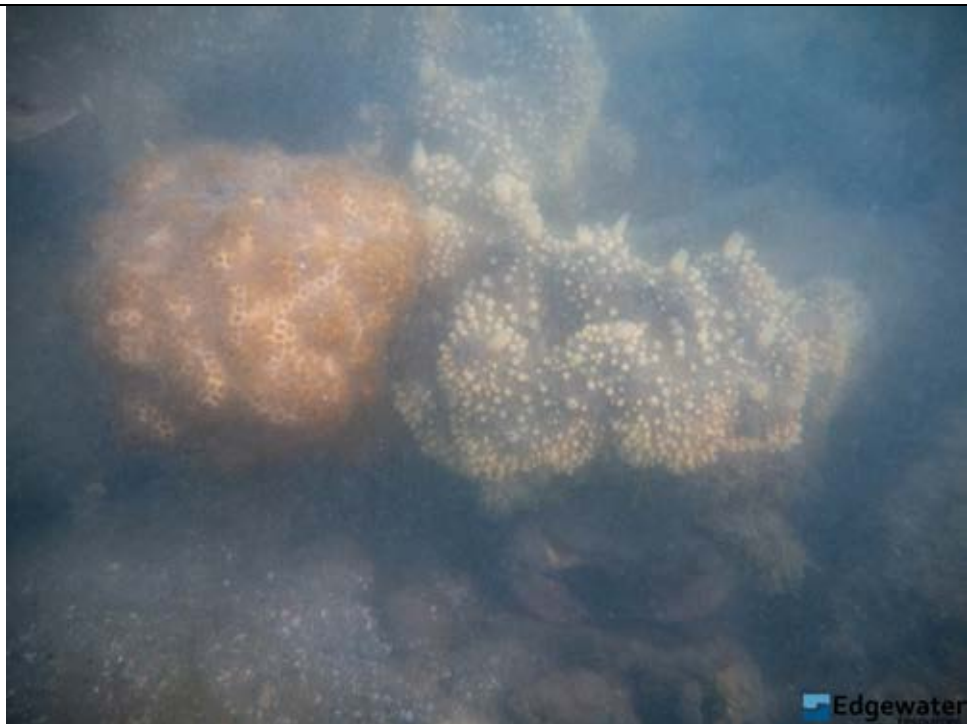
2

Solenastrea bournoni
corals and the boring
sponge *Cliona celata*
were observed along
the western end of
Transect A.
Numerous stone crabs
were also observed
associated with these
resources.

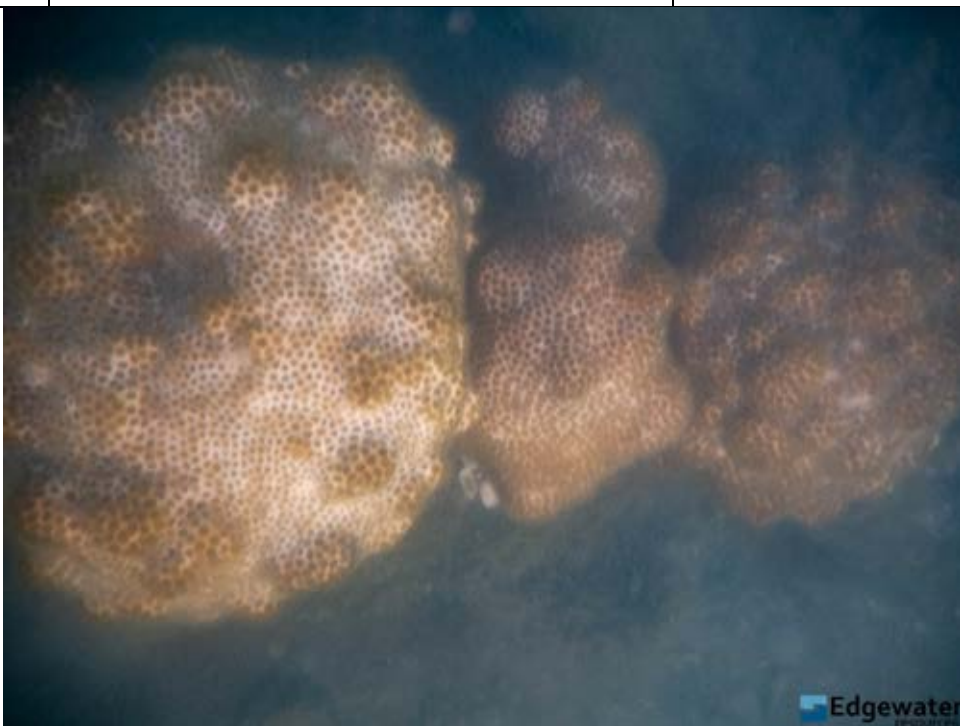
Photo Location: TS-A			
Description: Three large (>30 cm) <i>Solenastrea bournoni</i> coral colonies were observed growing along Transect A.			
Photo No. 4	Date: 8/27/19

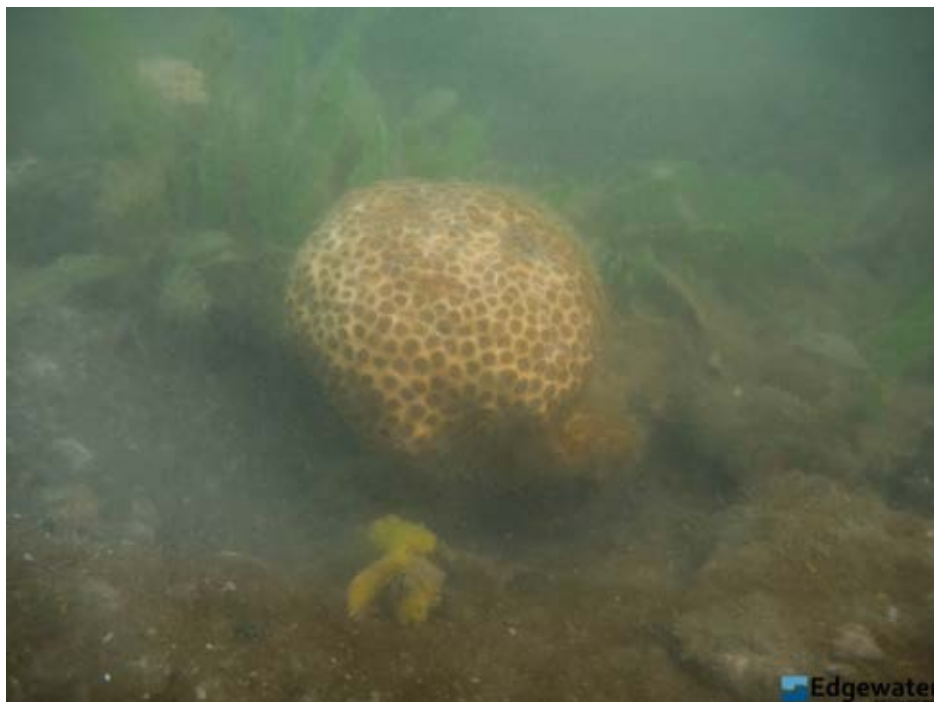
Photo Location: TS-A			
Description: The green macroalgae <i>Caulerpa sertularioides</i> was observed growing throughout the survey area as pictured here adjacent to a small <i>Solenastrea bournoni</i> was observed 221 feet from the start of Transect A.

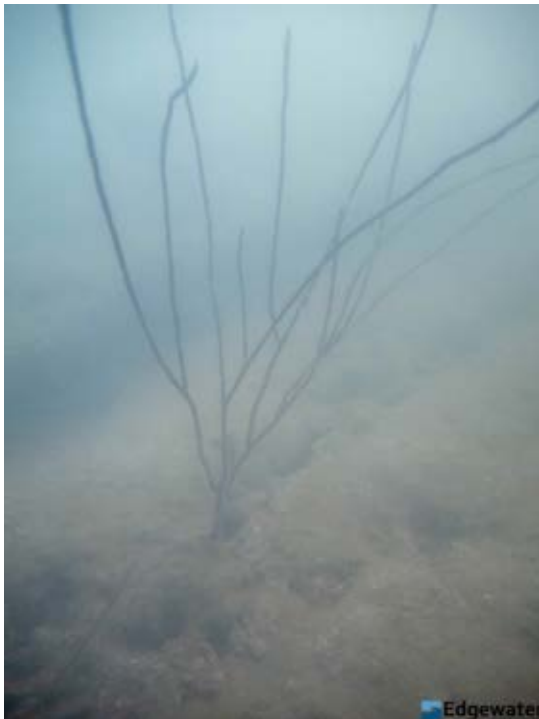
Photo Location: TS-A			
Description: <i>Leptogorgia virgulata</i> was the most common species of octocoral observed during the survey. Many large (>30cm tall) colonies were observed throughout the survey area.			
Photo No. 6	Date: 8/27/19

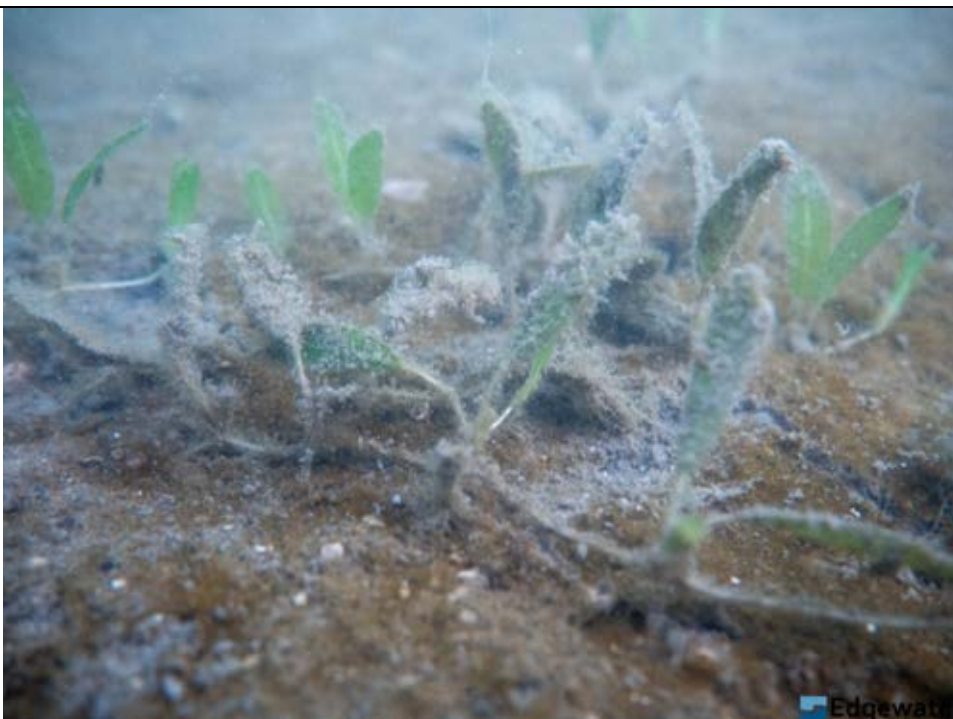
Photo Location: TS-A			
Description: A sparse patch of <i>Halodule decipiens</i> was observed 259 feet from the start of Transect A.

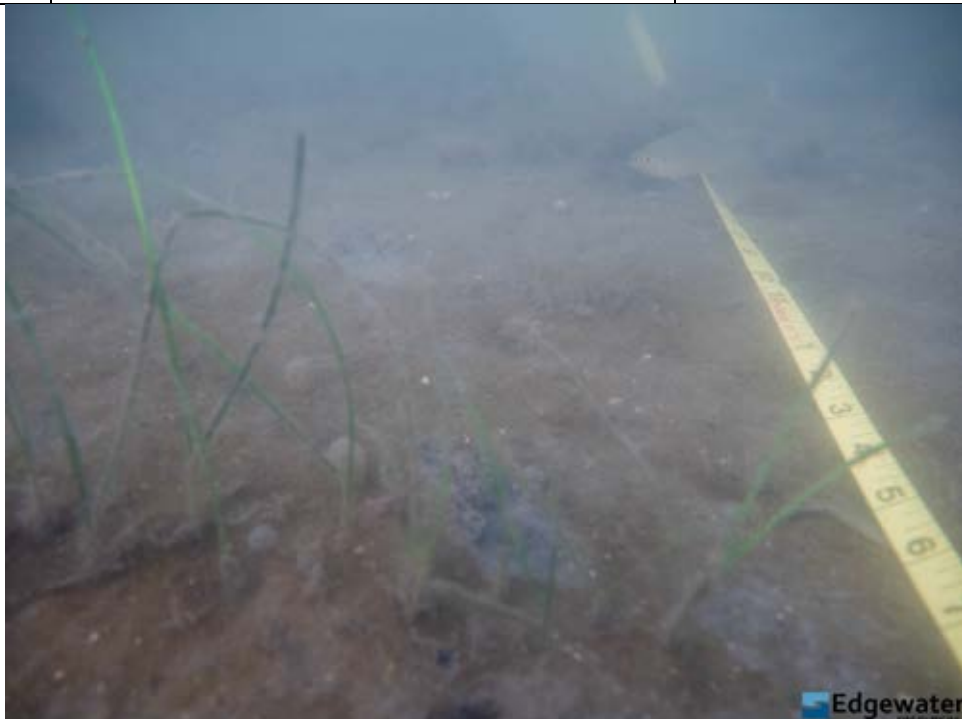
Photo Location: TS-A			
Description: <i>Sparse patches of the seagrass (Halodule wrightii) were located between 280 and 293 feet from the start of Transect A.</i>			
Photo No. 8	Date: 8/27/19

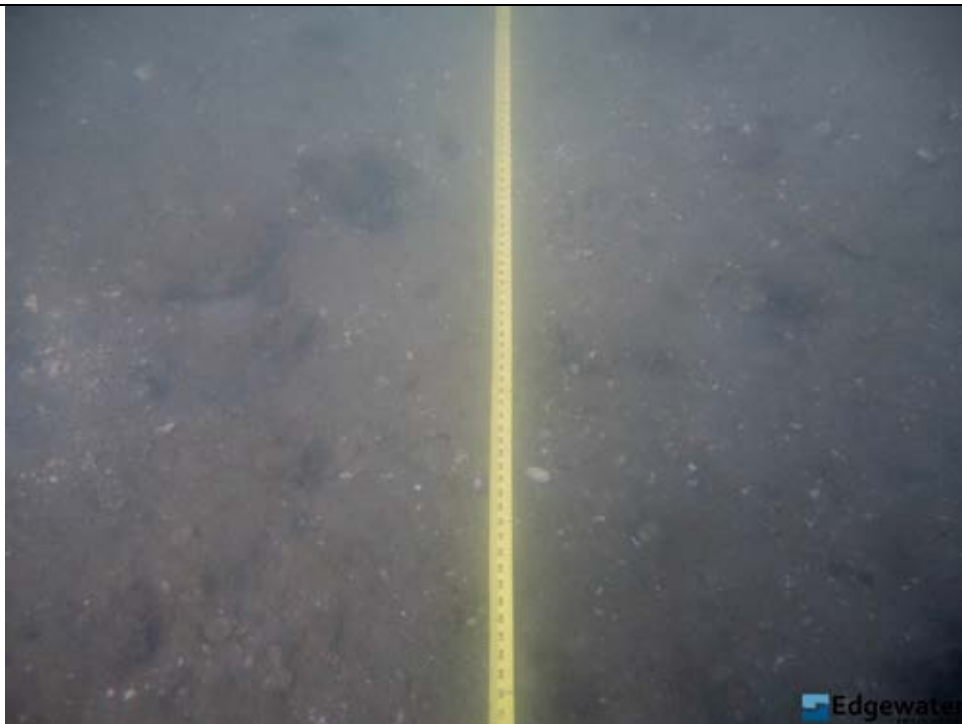
Photo Location: TS-A			
Description: The submerged bottom within the survey area consisted mostly of sand and silt as pictured here on Transect A.

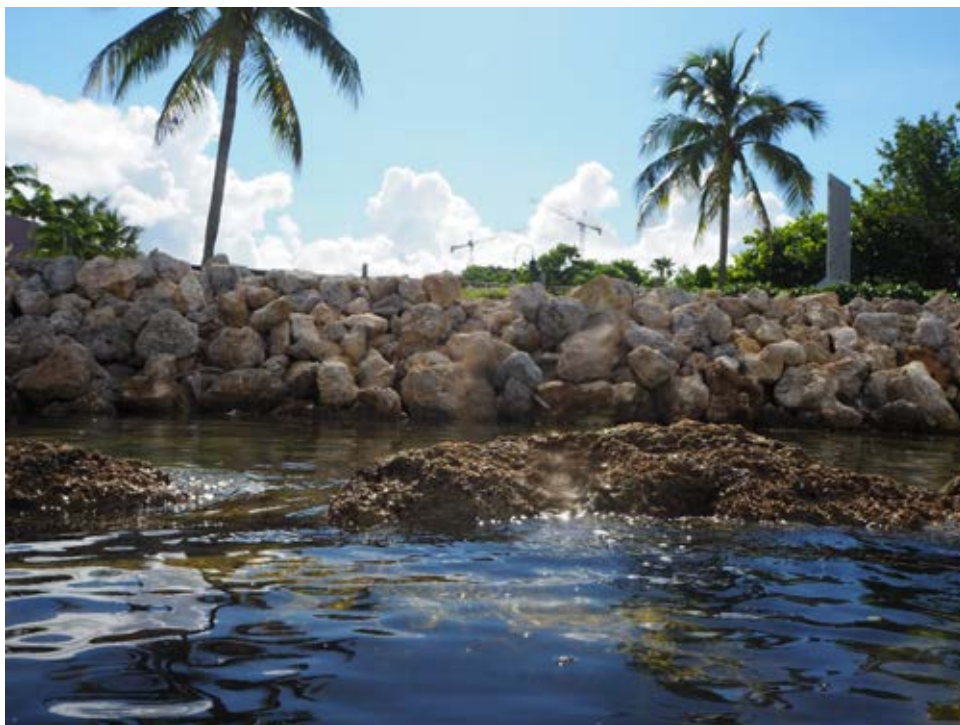
Transect B extended
314 feet west of the
outer riprap off the
western shoreline
north of the mangrove
creek.

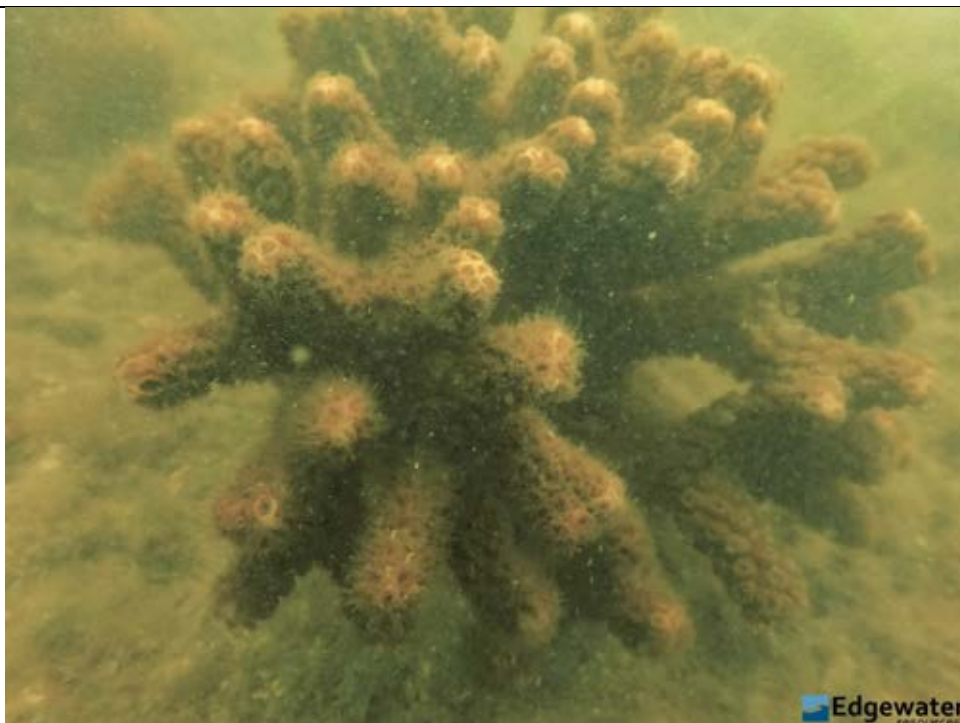
10

Occulina robusta
corals were observed
growing on rubble
throughout the survey
area such as this
colony observed 20
feet from the start of
Transect B.

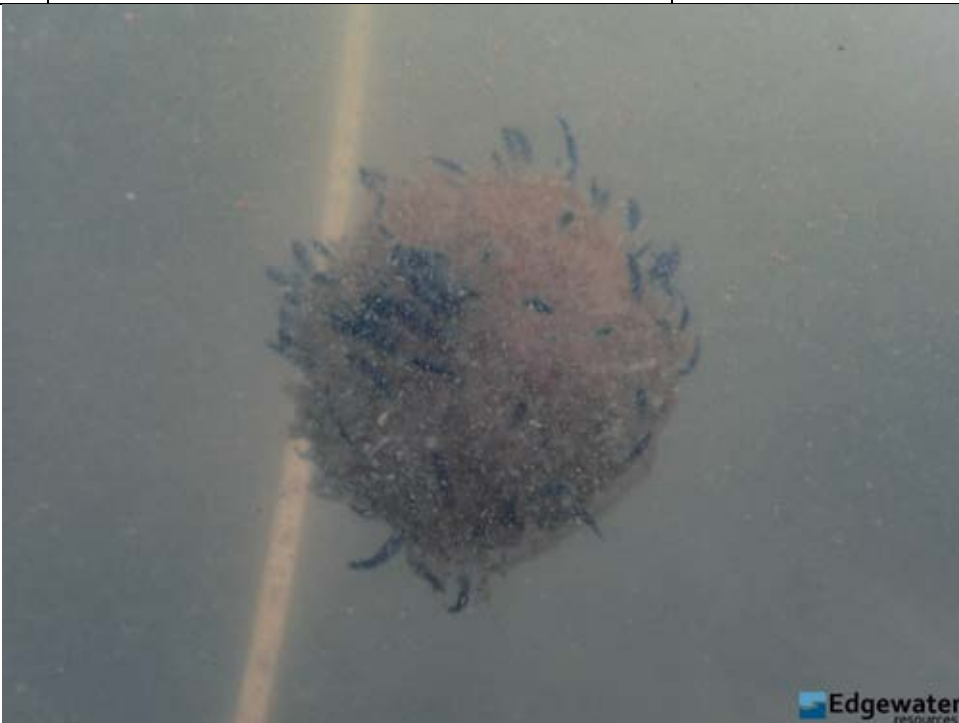
Photo Location: TS-B			
Description: One Upside down Jellyfish was observed along the beginning of Transect B.			
Photo No. 12	Date: 8/27/19

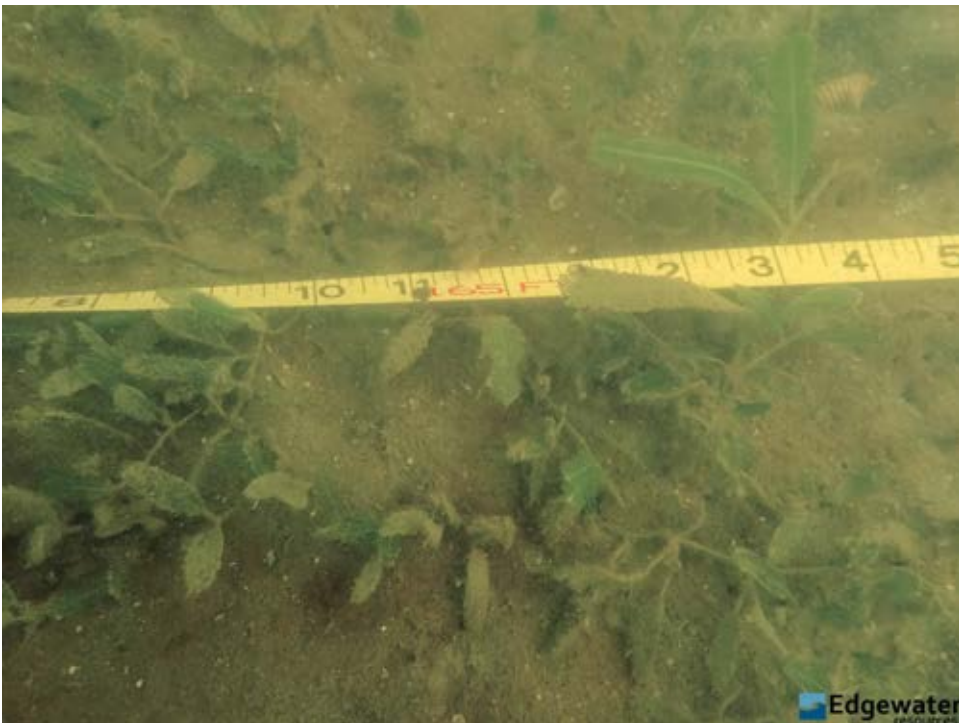
Photo Location: TS-B			
Description: A patch of <i>Halodule decipiens</i> seagrass and the green macroalgae (<i>C. sertularoides</i>) was observed 165 feet from the start of Transect B.

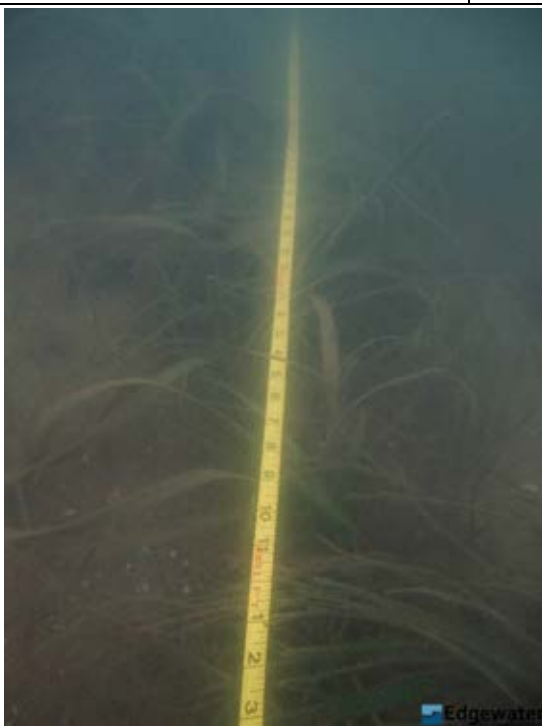
Photo Location: TS-B			
Description: A large bed of mixed seagrass (<i>Halodule wrightii</i> , <i>Syringodium filiforme</i> , and <i>Thalassia testudinum</i>) extended between 191 and 302 feet from the start of Transect B. A mixed bed of <i>H. wrightii</i> and <i>T. testudinum</i> was observed between 269 and 283 feet.			
Photo No. 14	Date: 8/27/19

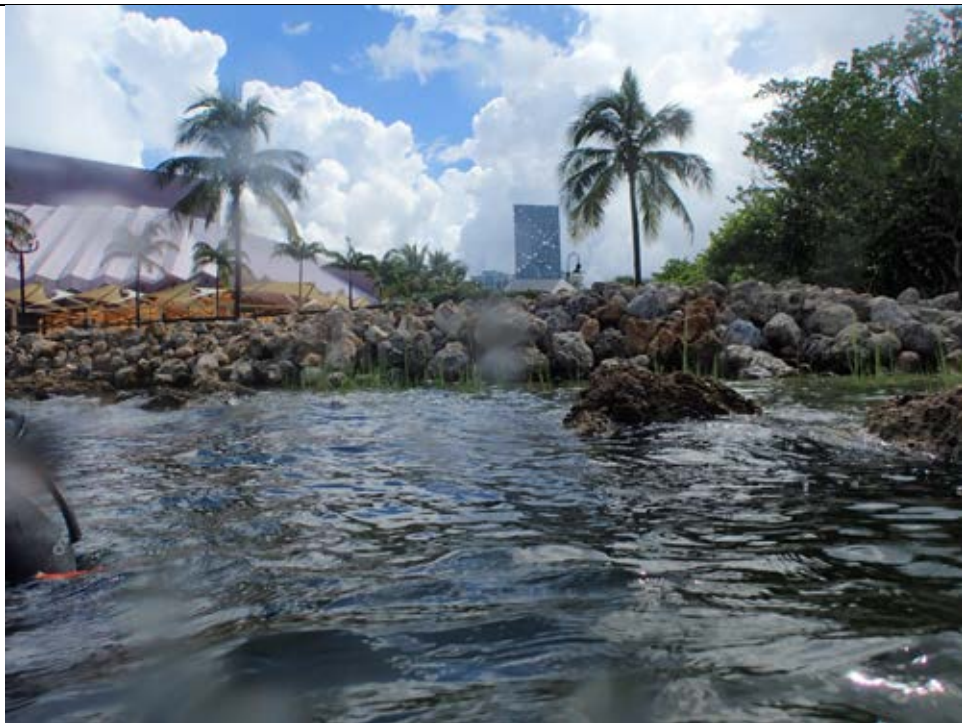
Photo Location: TS-C			
Description: Transect C extended 300 feet west of the outer riprap off of western shoreline north of the mangrove creek.

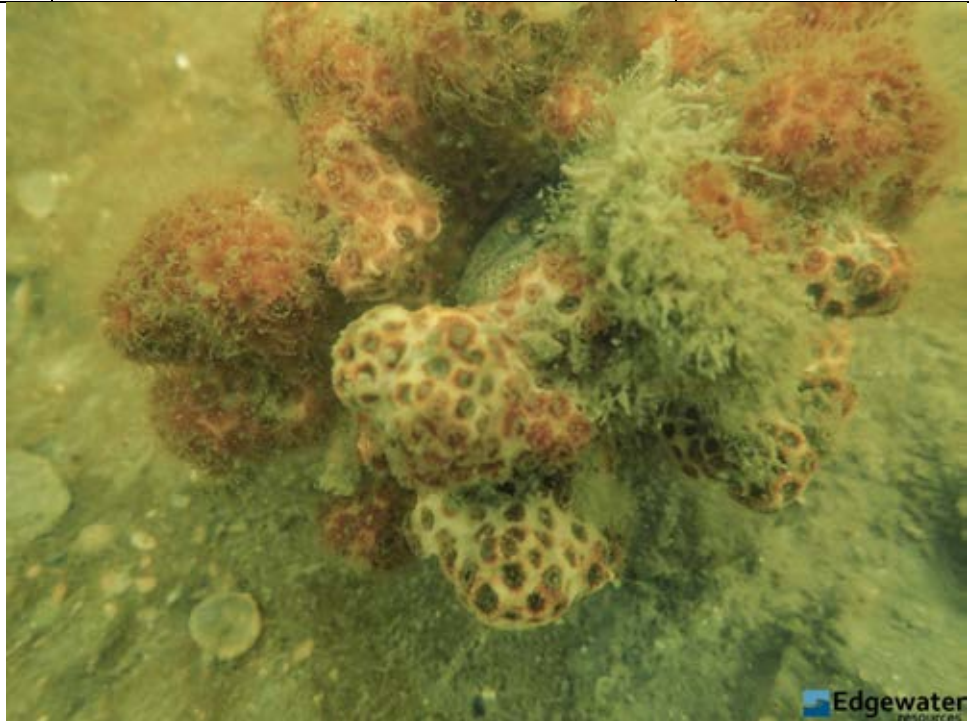
Oculina robusta coral
observed along
Transect C.

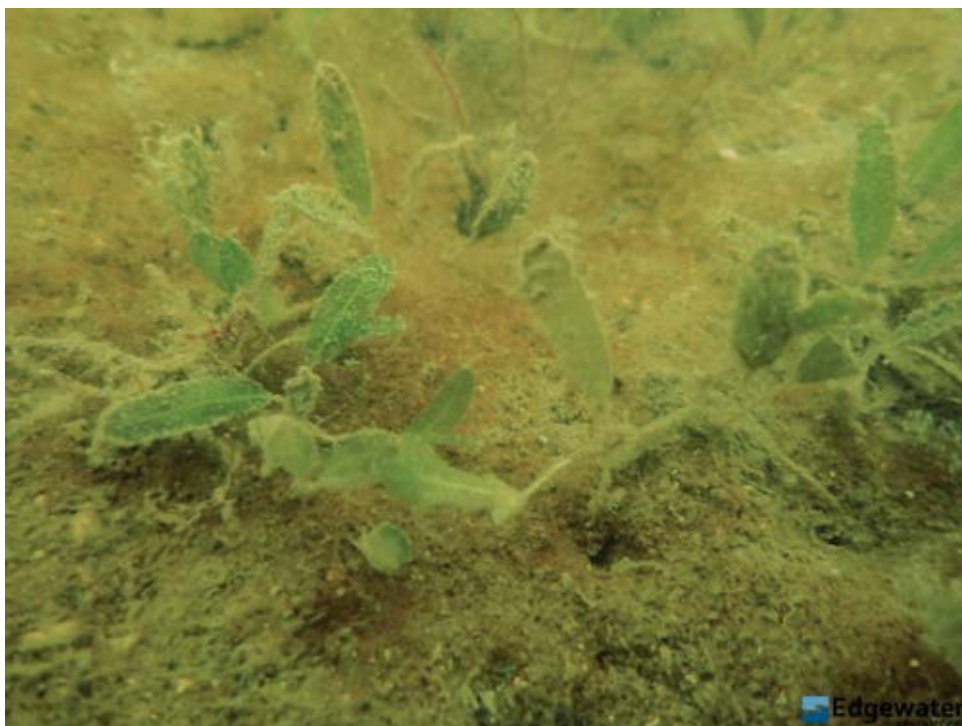
Photo Location: TS-C			
Description: Another sparse patch of <i>Halophila decipiens</i> was observed between 148 and 153 feet from the start of Transect C.			
Photo No. 18	Date: 8/27/19

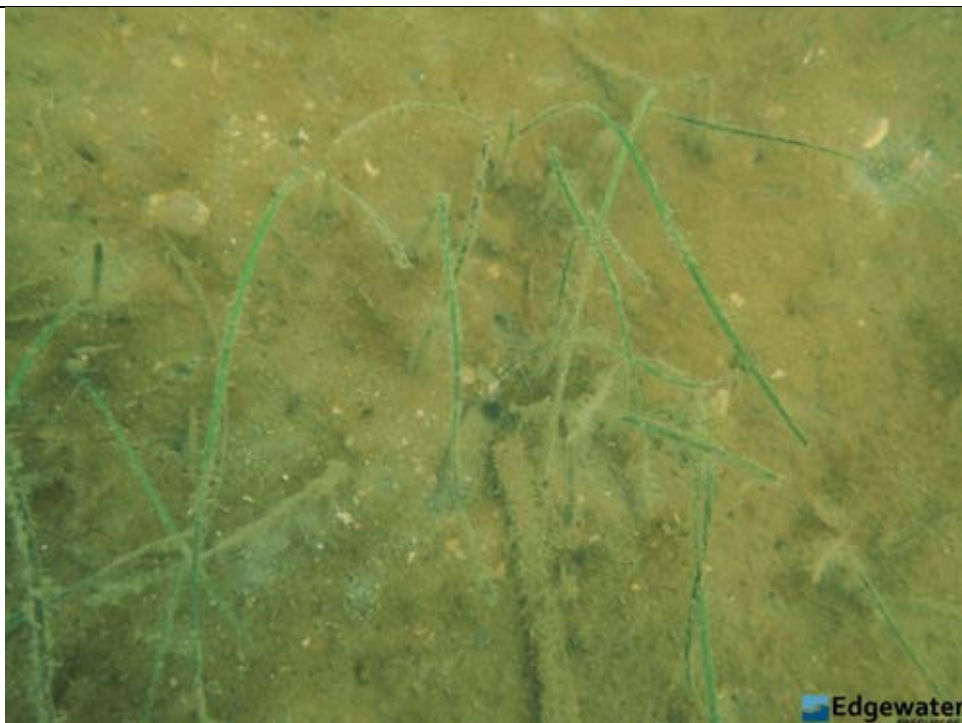
Photo Location: TS-C			
Description: Sparse <i>Halodule wrightii</i> seagrass was located along Transect C at the end of the transect, near the riprap.

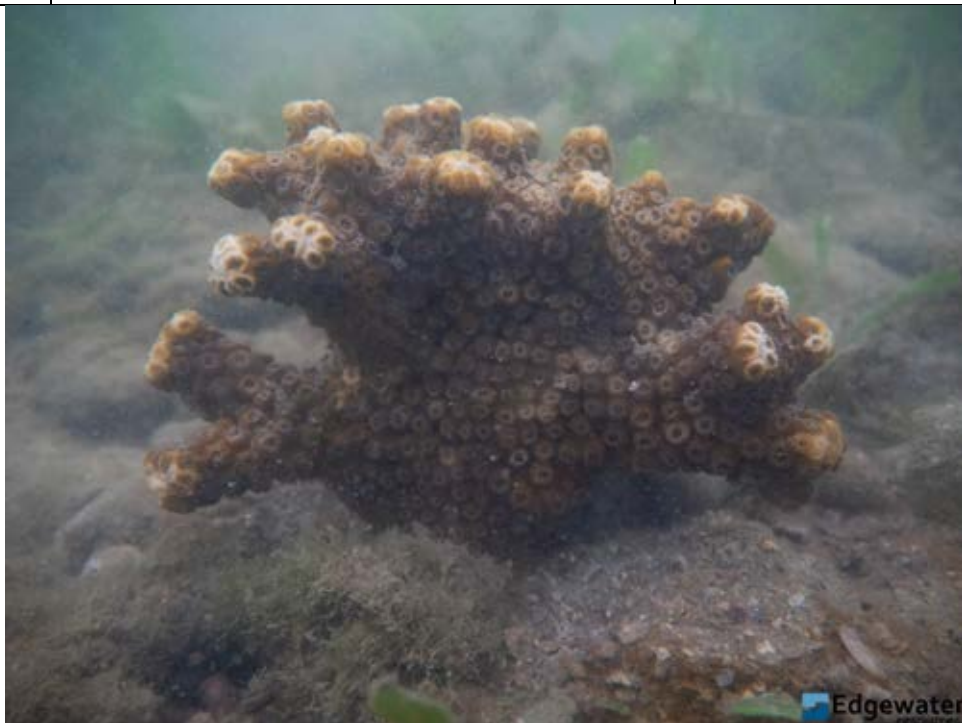
Photo Location: TS-D			
Description: <i>Occulina robusta</i> corals were observed growing on rocks and rubble throughout the survey area. This colony was located 215 feet from the start of Transect D.			
Photo No. 20	Date: 8/27/19

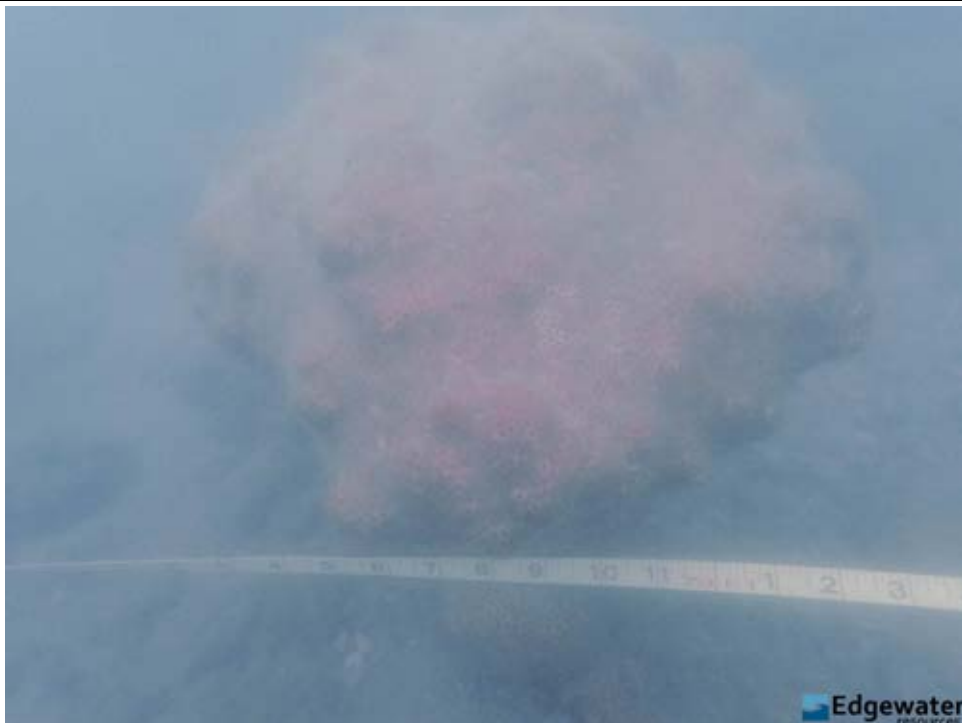
Photo Location: TS-D			
Description: Numerous large (>30cm) <i>Solenastrea bournoni</i> corals were observed growing within the survey area. The corals were observed in the offshore region of the transects such as this colony located 73 feet from the start of TS-D.

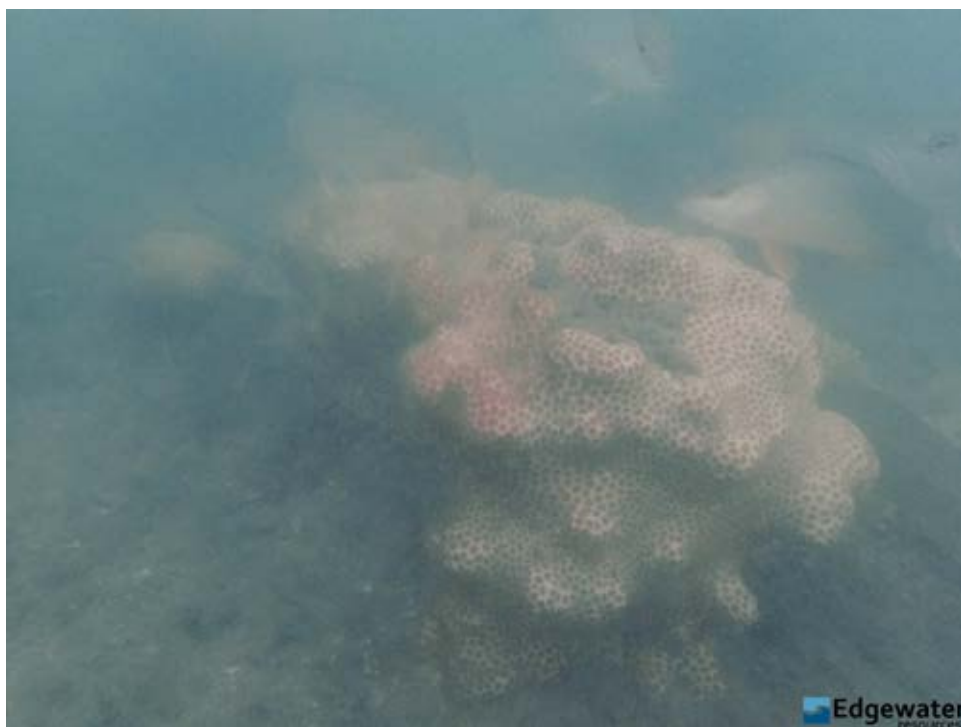
The large *Solenastrea*
sp. colonies growing
along Transect D
provide habitat for
stone crabs and gray
snapper, as pictured
here.

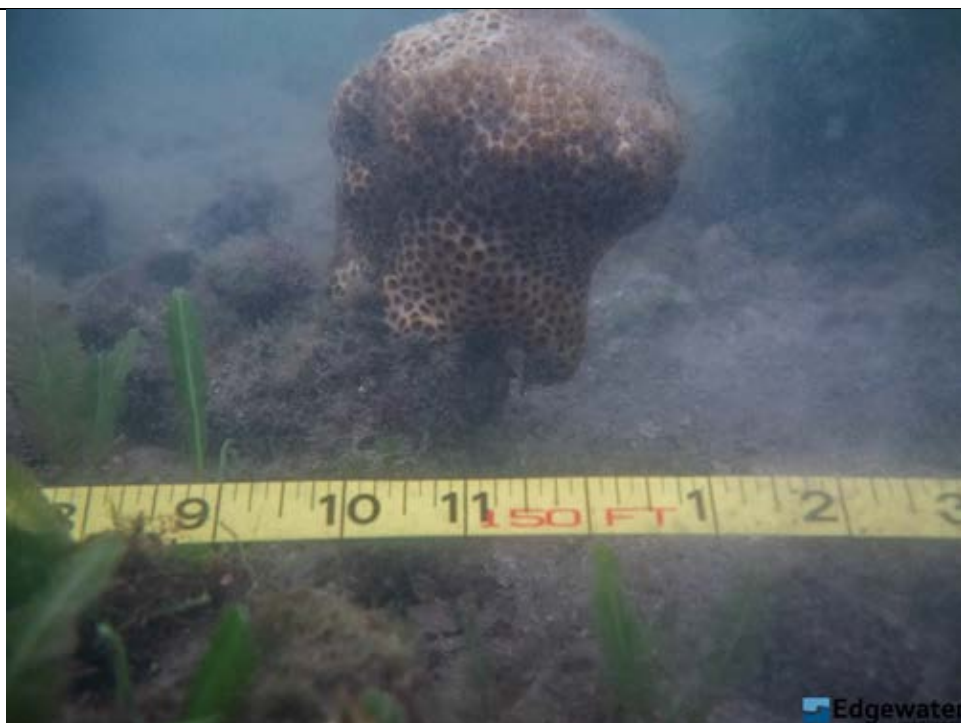
22

Solenastrea bournoni
and *Caulerpa*
sertularoides were the
most commonly
observed corals and
macroalgae,
respectively, growing
within the survey
area.

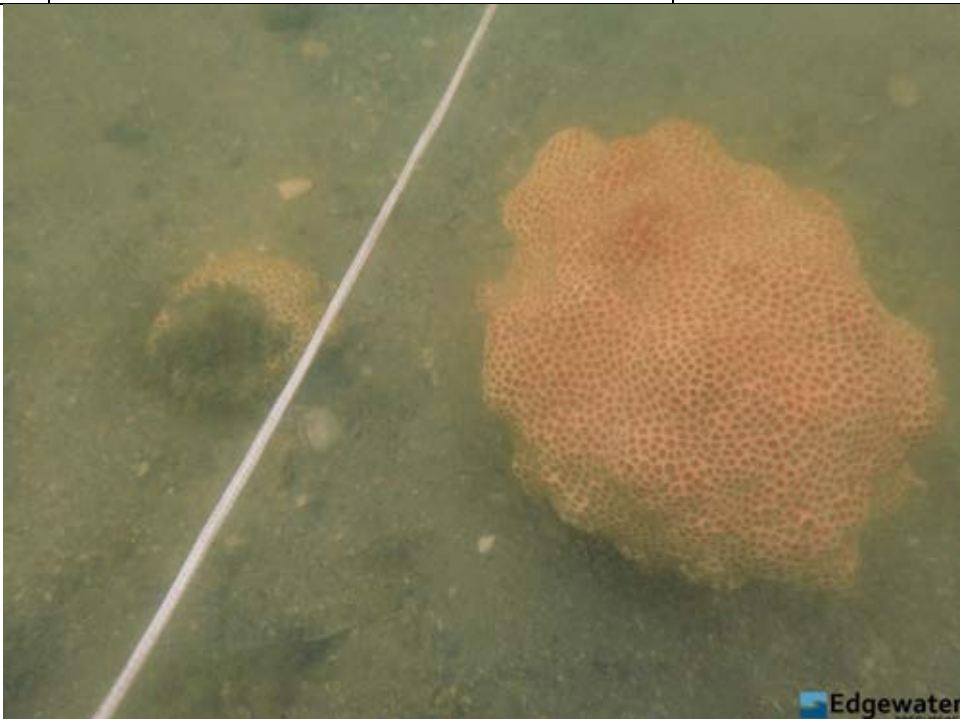
Photo Location: TS-F			
Description: Several <i>Solenastrea bournoni</i> colonies were observed growing in the offshore region of Transect F.			
Photo No. 24	Date: 8/27/19

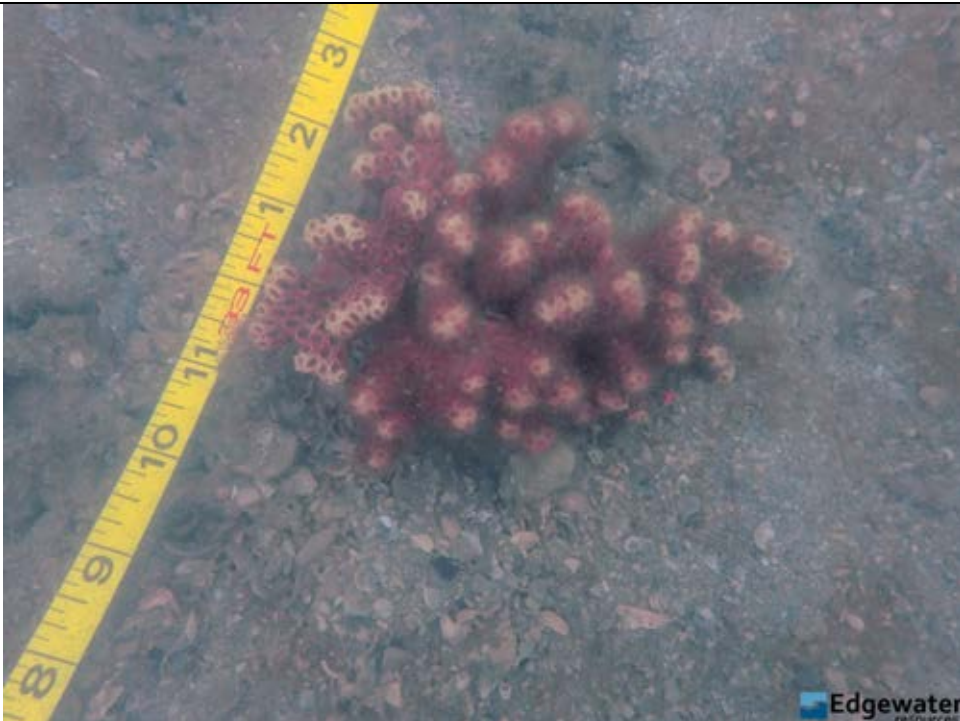
Photo Location: TS-F			
Description: <i>Oculina robusta</i> corals were observed growing on rubble throughout the survey area. This colony was seen 33 feet from the start of Transect F.

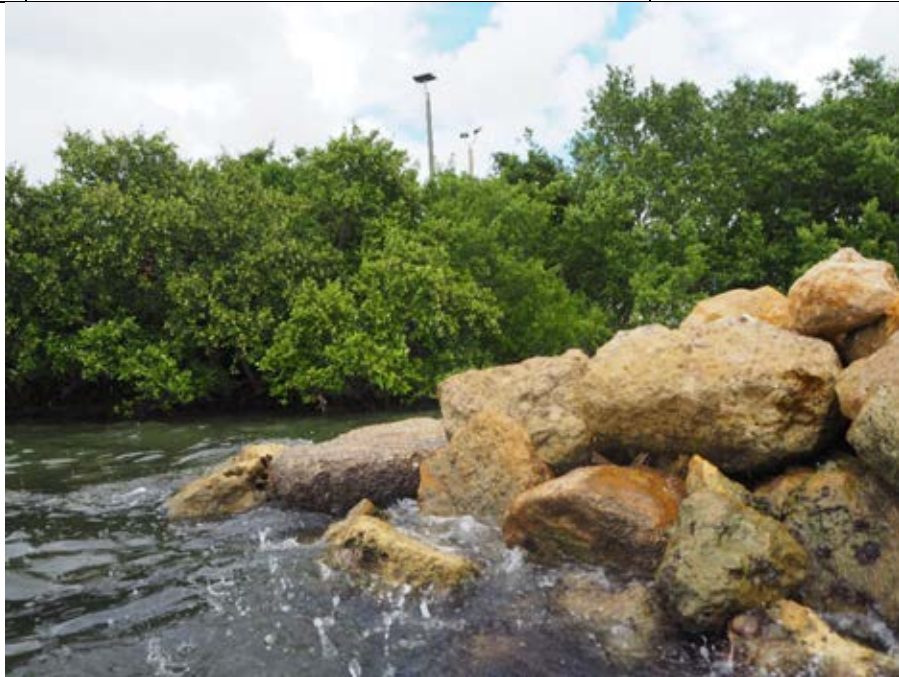
Transect H extended
314 feet west of the
outer riprap off the
western shoreline,
south of the
mangrove creek.

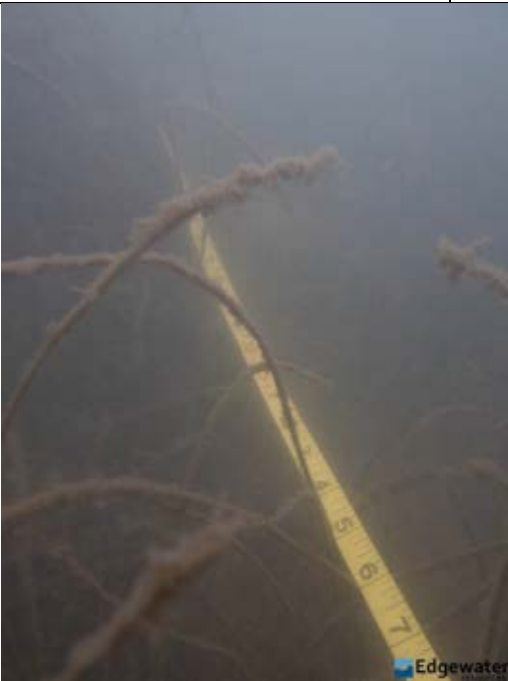
Photo Location: TS-H					
Description: A mixed seagrass bed of <i>Syringodium filiforme</i> , <i>Halodule wrightii</i> and <i>Thalassia testudinum</i> was located 251 to 293 feet from the start of Transect H.					
Photo No. 28	Date: 8/27/19

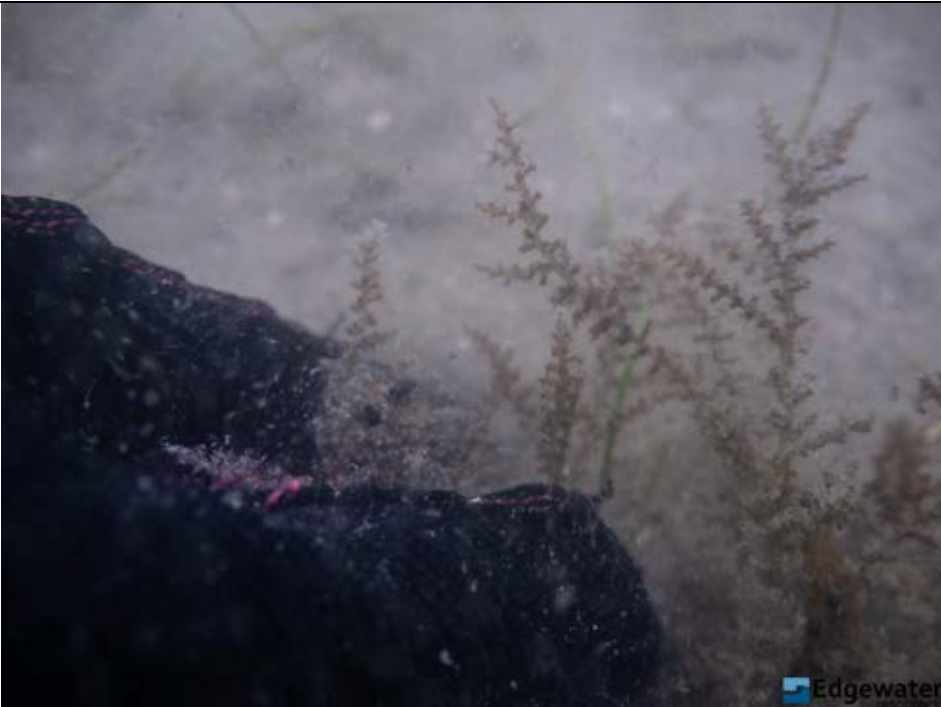
Photo Location: TS-H					
Description: The red macroalgae <i>Acanthaphora spicifera</i> was observed in the nearshore region along several transects.

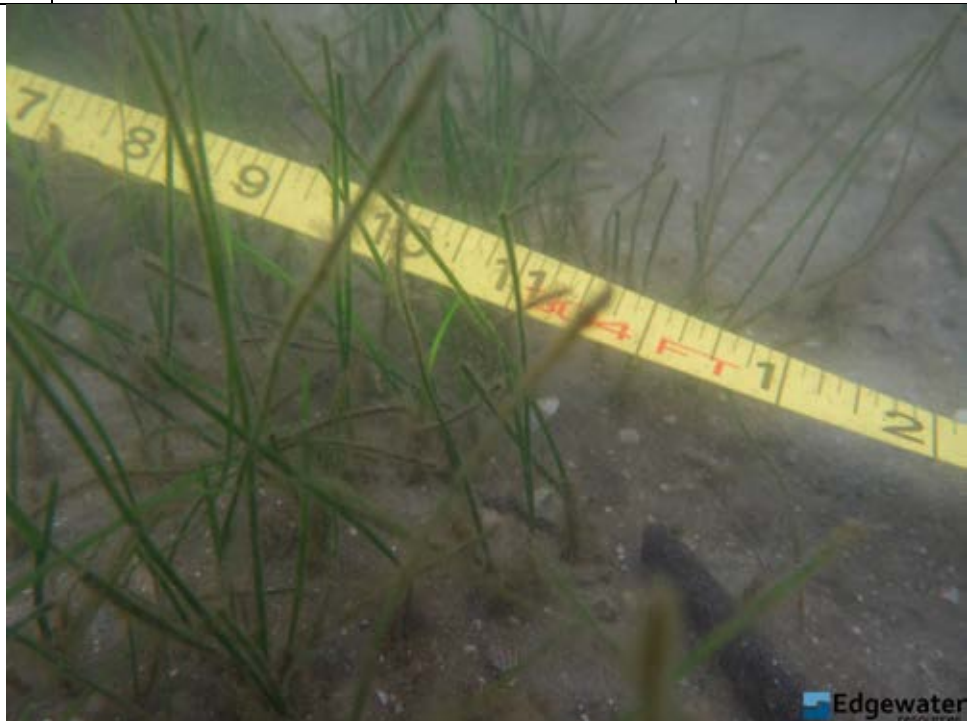
A bed of *Halodule wrightii* seagrass was located along the shallow nearshore region of Transect H.

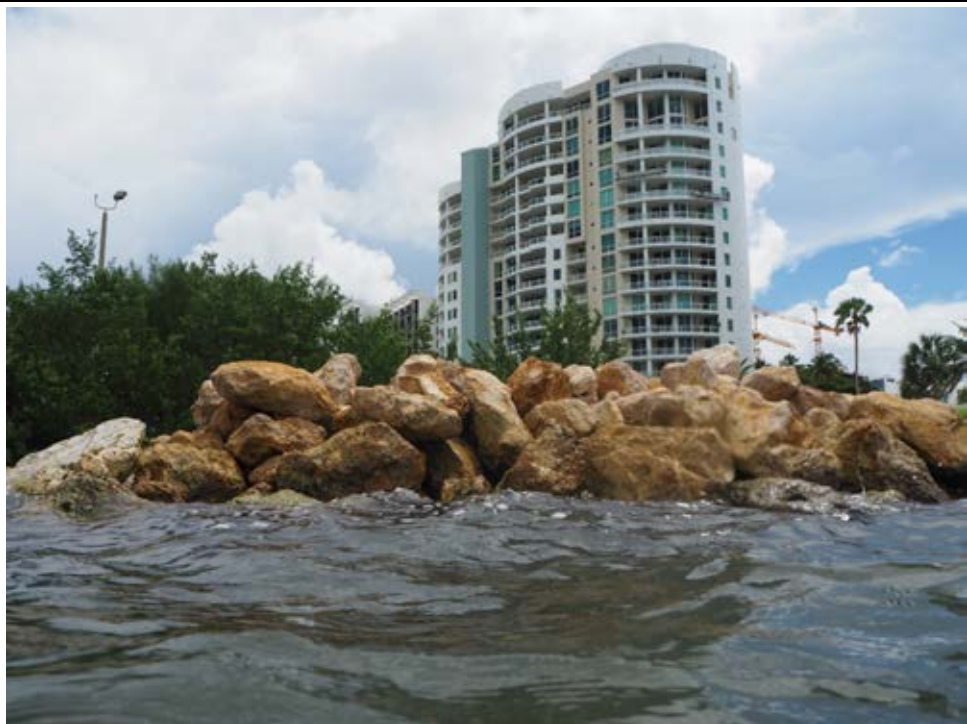
30

Transect I extended 309 feet west of the outer riprap, off the western shoreline, south of the mangrove creek.

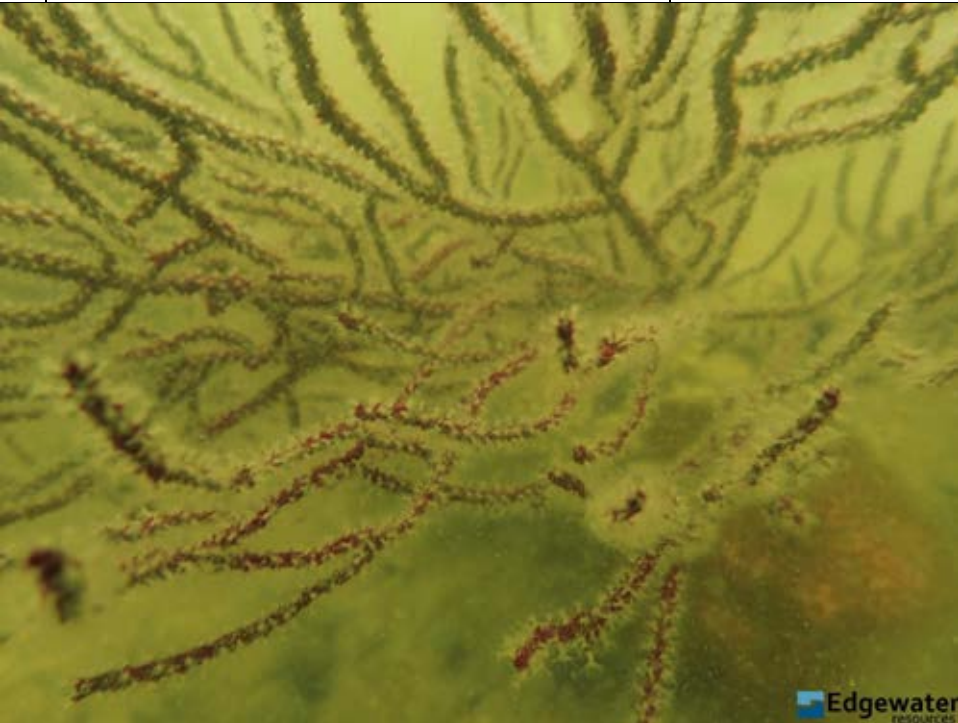
Photo Location: TS-I			
Description: The octocoral <i>Leptogorgia hebes</i> was observed growing along Transect I.			
Photo No. 32	Date: 8/27/19

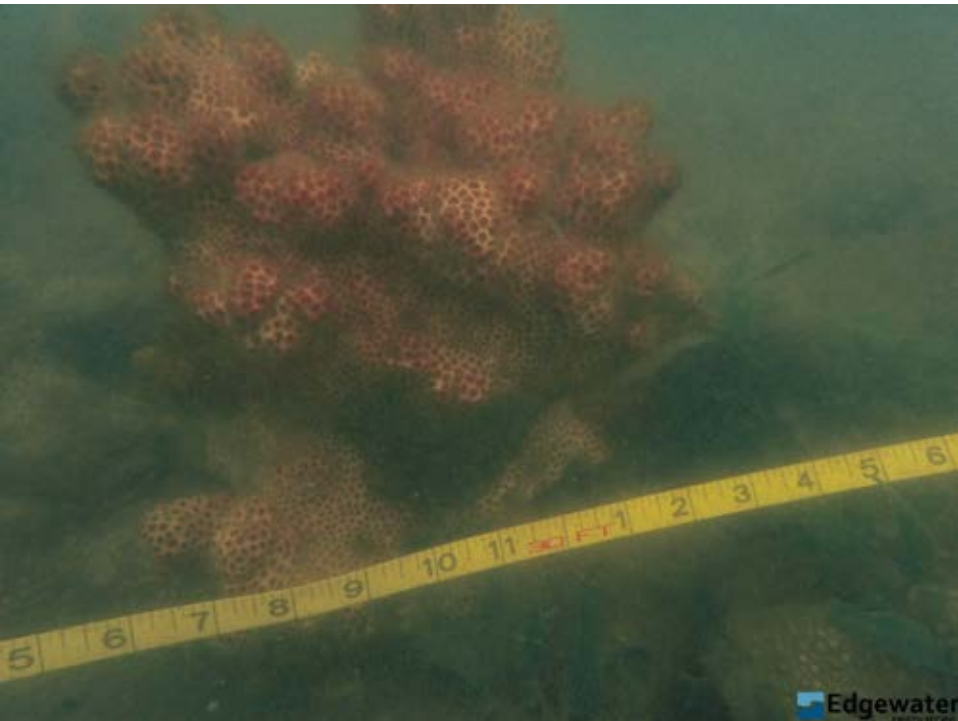
Photo Location: TS-I			
Description: A large (>30 cm) <i>Solenastrea hyades</i> observed growing 30 feet from the start of Transect I in the offshore region of the Transect.

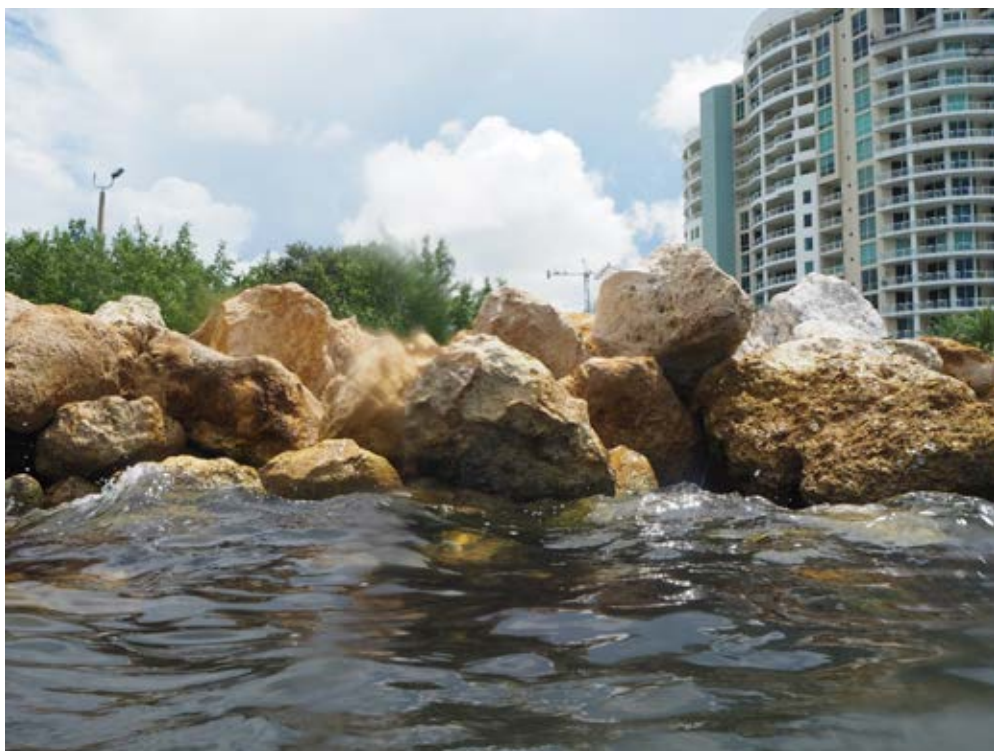
34

Transect J extended
315 feet west of the
outer riprap off, of the
western shoreline,
south of the
mangrove creek.

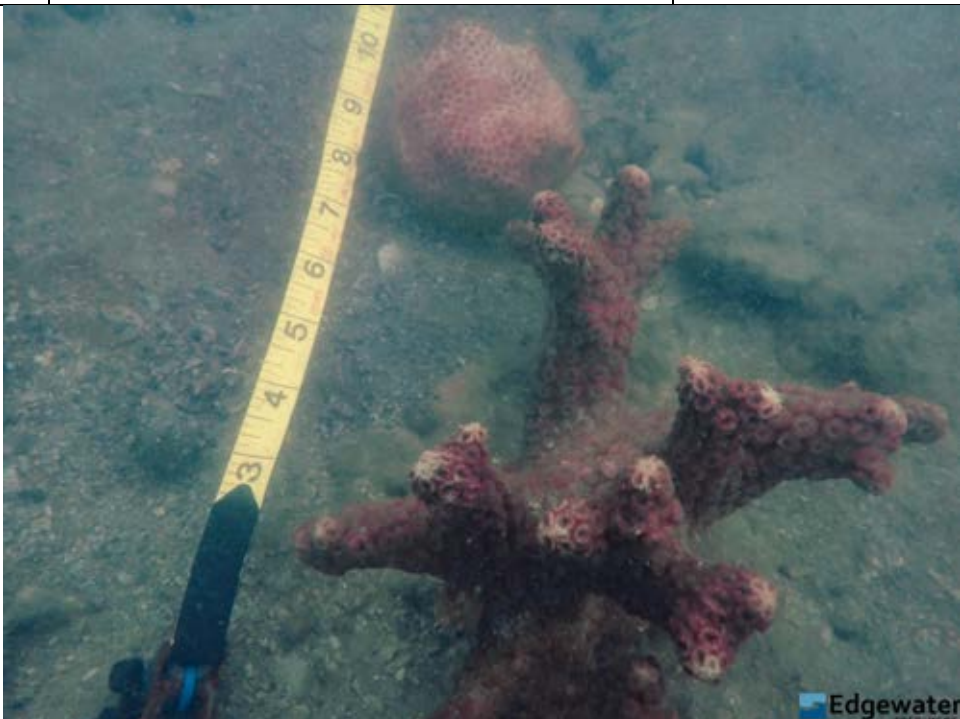
Photo Location: TS-J			
Description: An <i>Occulina robusta</i> and a <i>Solenastrea bournoni</i> coral were observed at the start of Transect J.			
Photo No. 36	Date: 8/27/19
