2019 Sarasota Bay Phase I – Marine Resource Survey Report

Report Date: September 26, 2019

Issued To: Sarasota Bayfront Planning Organization

Survey Date: August 27, 2019

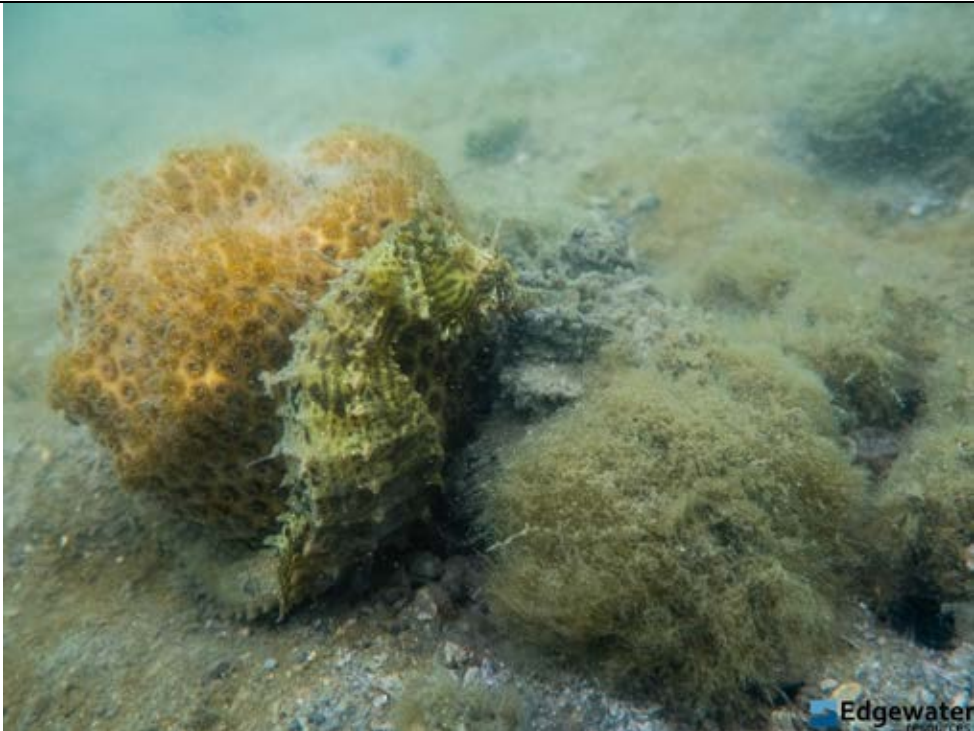
Photo Location: TS-J			
Description: A Lined Seahorse resting beside a <i>Solenastrea bournoni</i> coral along Transect J.

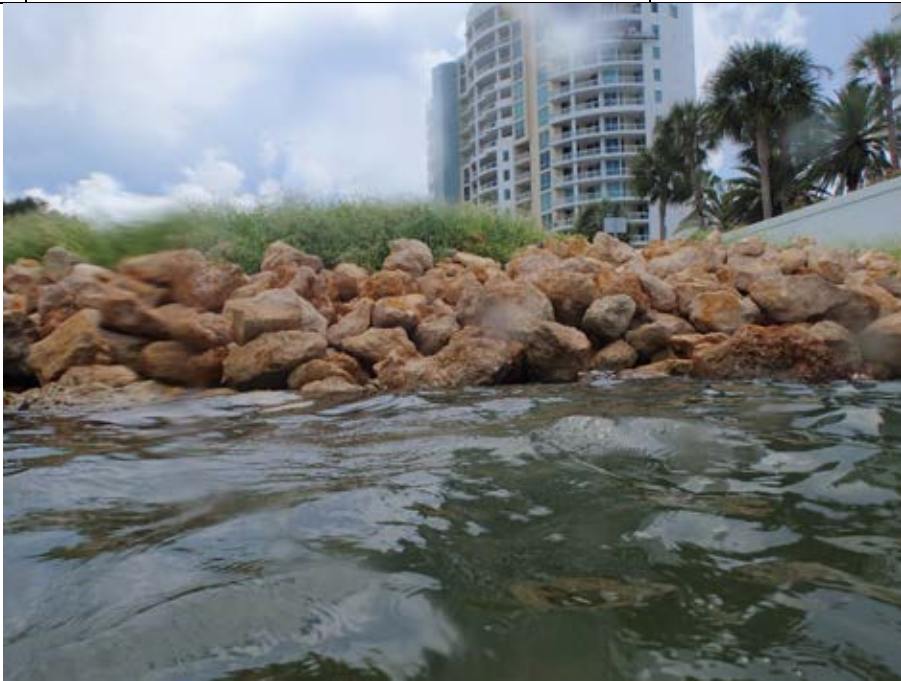
Photo Location: TS-K					
Description: Transect K extended 324 feet west of the southern property line, terminating at the riprap along the shoreline.					
Photo No. 38	Date: 8/27/19

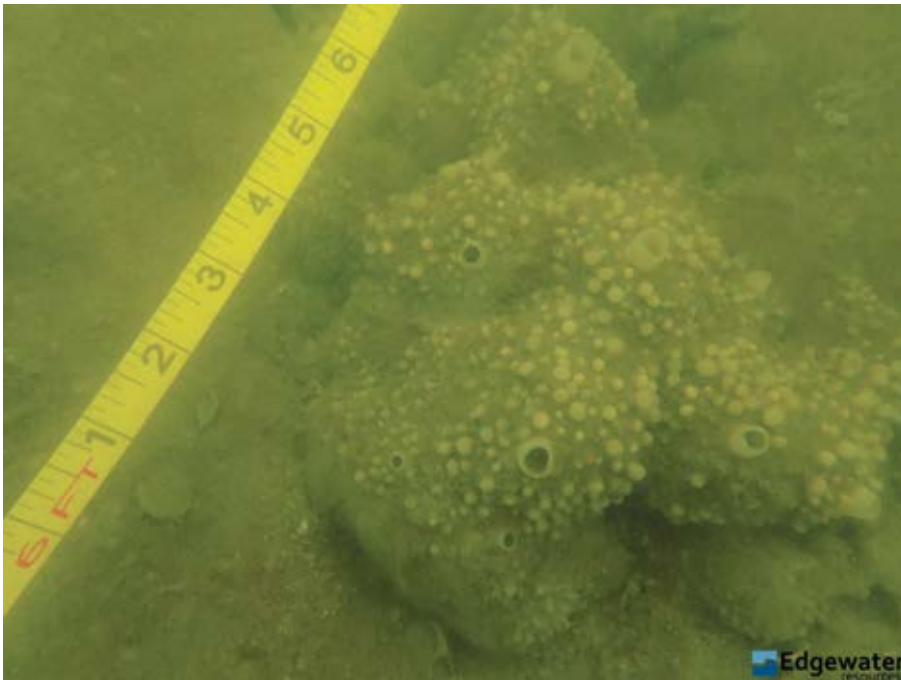
Photo Location: TS-K					
Description: A large boring sponge (<i>Cliona celata</i>) observed along the western portion of Transect K.

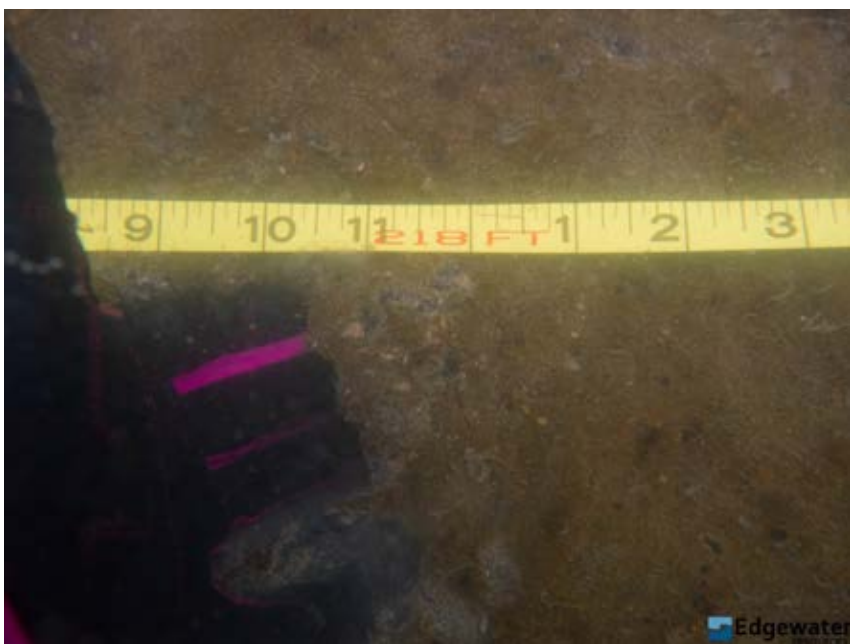
Photo Location: TS-K			
Description: Silty sediment was observed along a portion of all the transects, as pictured here at 218 feet along Transect K.			
Photo No. 40	Date: 8/27/19

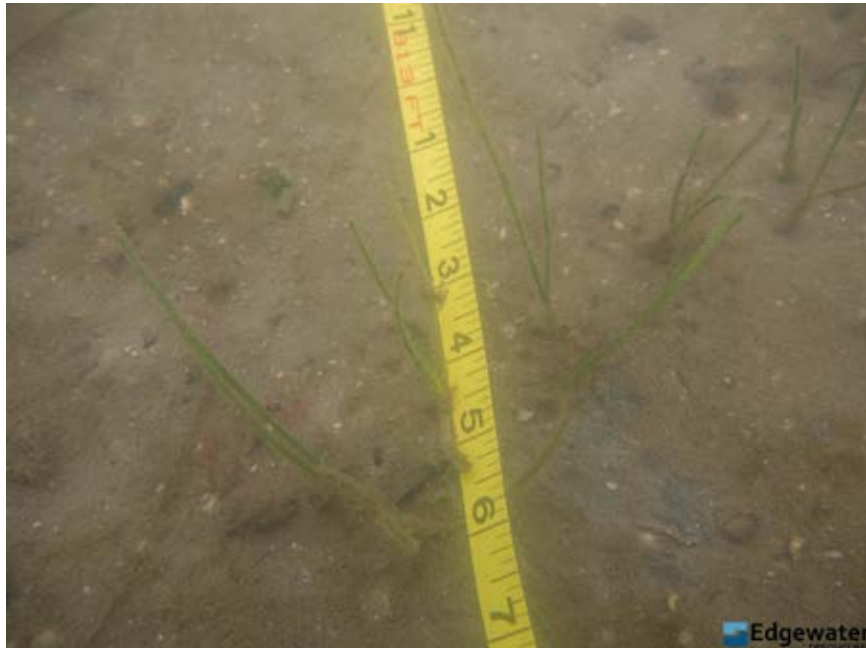
Photo Location: TS-K			
Description: Sparse <i>Halodule wrightii</i> was observed growing in the nearshore region along Transect K.
